**Flood Control Project Maintenance  
Levee Inspections**

## Maintenance Issue Types Only, Levee Inspection Report By Mile - Spring 2019

### Merced Streams Group

Waterway	Bank	Unit Miles	Inspection Start/End	Inspector
Unit No. 01 Black Rascal Diversion	Right	1.61	04/30/2019 04/30/2019	Corey Fujitani

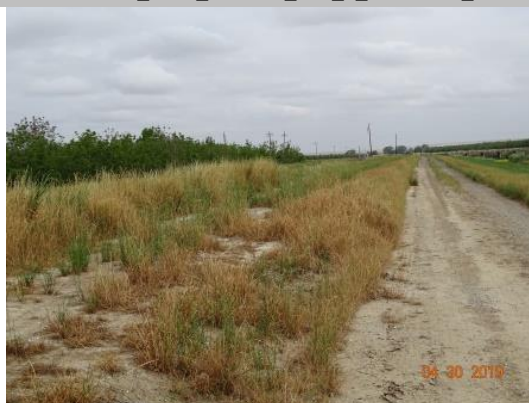
Photo 1 of 1 : SP\_2019\_NA0013\_331\_2\_20190501\_00012.jpg

View of landside slope looking upstream. (Spring 2019)

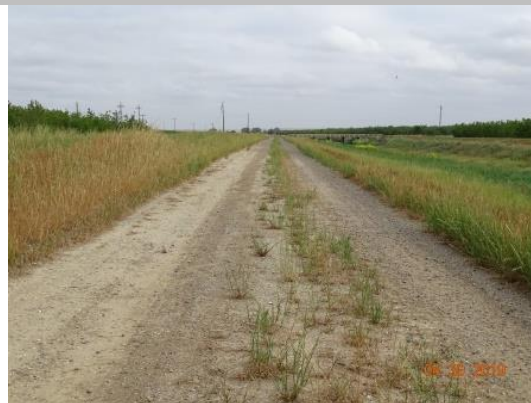
Photo 1 of 1 : SP\_2019\_NA0013\_331\_12\_20190501\_00013.jpg

View of vegetation along levee crown looking upstream. (Spring 2019)

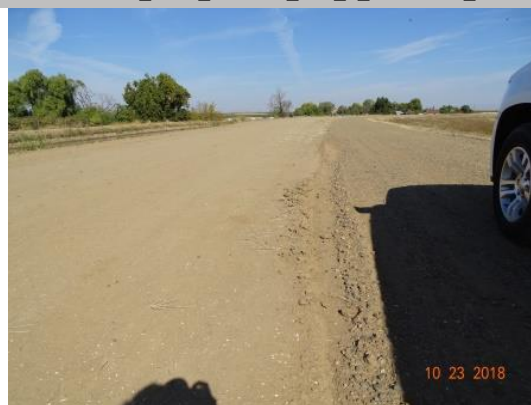
Photo 1 of 2 : SP\_2019\_NA0013\_331\_8\_20190307\_00004.jpg

LM Start	0.27	Rating **	A/W	Issue No.	8
LM End	1.62	Issue Type +	Ma	Location *	CR
Category	Earthen Levee			GPS Latitude/Longitude	
				Start	End
Item	Crown Surface / Depressions / Rutting			37.318525 °	37.337176 °
				-120.396598 °	-120.396531 °
DWR ID	DWR_NA0013_01_s_2018_8				
Comment Code					
C2 : Repair depressions or ruts in the crown or slope.					
Inspector Comment					
Vehicle tracks and rutting on the crown should be repaired.

View of vehicle tracks on levee crown. (Fall 2018)

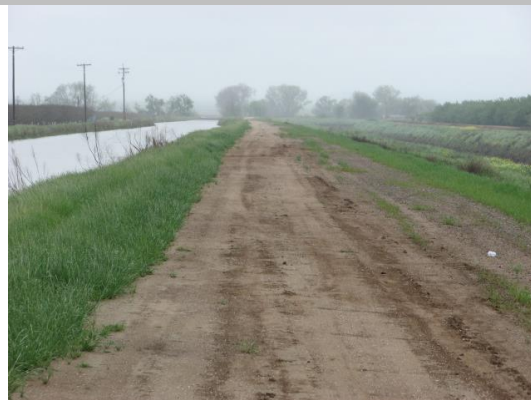
Photo 2 of 2 : SP\_2019\_NA0013\_331\_8\_20190307\_00005.jpg

Looking downstream at typical view of levee crown (Spring 2018)

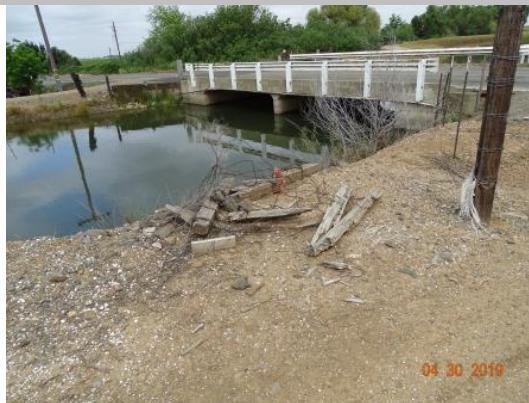
Photo 1 of 1 : SP\_2019\_NA0013\_331\_16\_20190501\_00015.jpg

LM Start	1.23	Rating **	M	Issue No.	16
LM End	1.23	Issue Type +	Ma	Location *	CR
Category	Earthen Levee			GPS Latitude/Longitude	
				Start	End
Item	Repair Gates			37.332005 °	37.332005 °
				-120.394751 °	-120.394751 °
DWR ID	DWR_NA0013_01_s_2019_16				
Comment Code					
Inspector Comment					
Gate is in disrepair and appears to have been removed.

View of barbed wire gate discarded on levee. (Spring 2019)

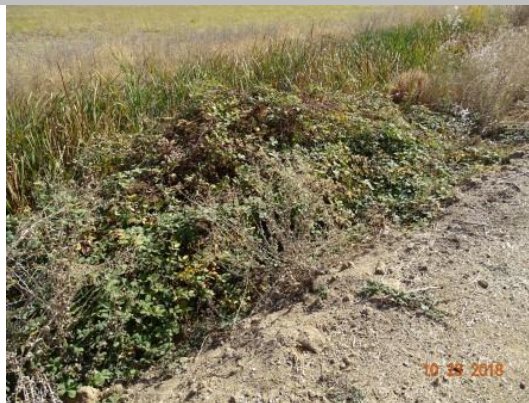
Photo 1 of 1 : SP\_2019\_NA0013\_331\_3\_20190307\_00001.jpg

Wild blackberry bushes on waterside slope. (Fall 2018)

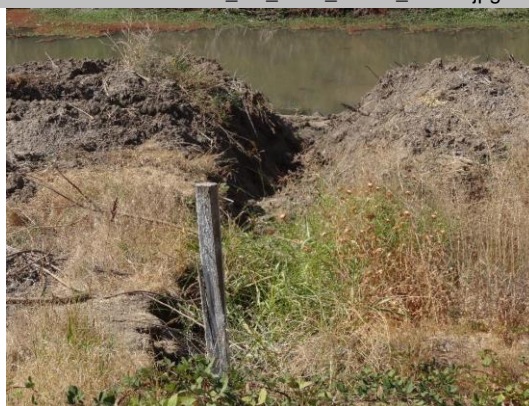
Photo 1 of 3 : UCIP\_SP\_2019\_50156\_35245.jpg

WS view: cobble spillway and channel on waterside.

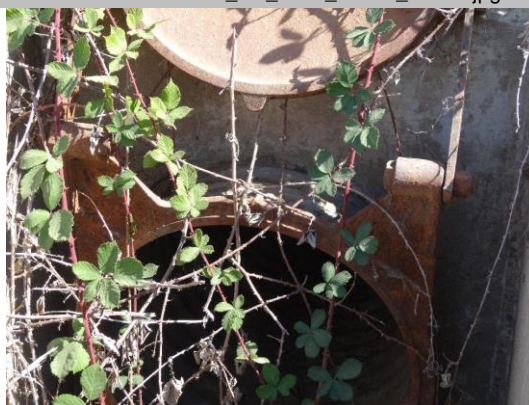
Photo 2 of 3 : UCIP\_SP\_2019\_50156\_35244.jpg

WS view: U typed concrete headwall, CM pipe, and flap gate. Flap gate was not closed. Vegetation needs to be cleared.

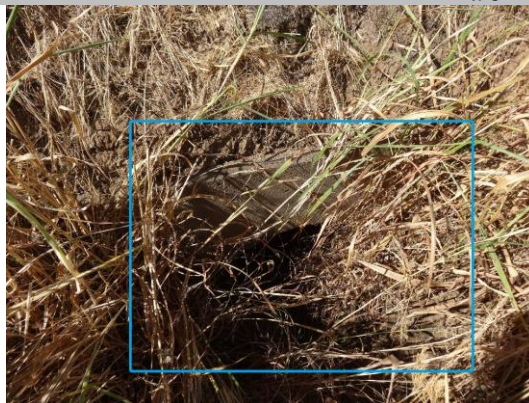
Photo 3 of 3 : UCIP\_SP\_2019\_50156\_35246.jpg

LS view: concrete headwall and CM pipe. Inlet needs cleaning.

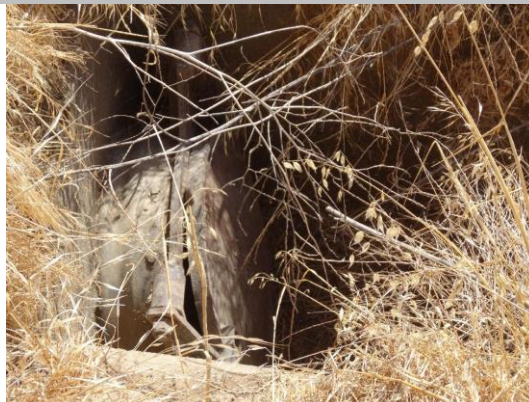
Photo 2 of 3 : UCIP\_SP\_2019\_20946\_35265.jpg

WS view: U typed concrete headwall, CM pipe, and flap gate. Flap gate was not properly closed.

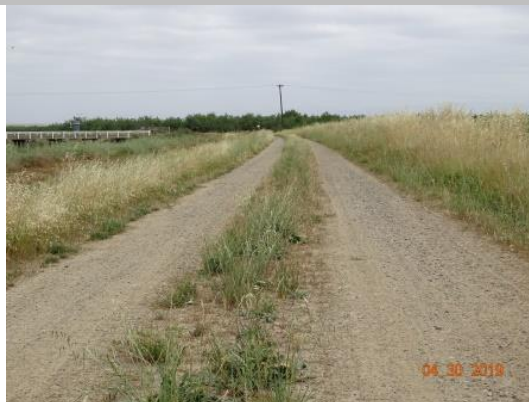
Photo 1 of 1 : SP\_2019\_NA0013\_332\_26\_20190501\_00044.jpg

View of vegetation along levee crown. (Spring 2019)

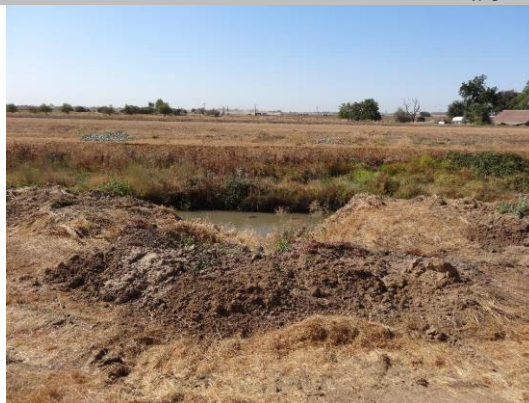
Photo 1 of 3 : UCIP\_SP\_2019\_20992\_35370.jpg

Comment Code					
Inspector Comment					
FS_ID:20992					
DS_ID:23055					
EP_NO: N/A					
Repair Type: Non-Urgent					
Crossing Status: Found					
UCIP Comments: 09/17/2013 - mud and debris from recent channel cleaning needs to be removed from spillway and outlet - pipe filled with debris, it needs cleaning.- half of inlet pipe buried. (DWR UCIP - P. Amatya)					
FIELD_STRUCT_DESC: 24-inch corrugated metal gravity drainage pipe through the levee, 8 feet below the crown. Concrete headwall, flap gate, and concrete grouted cobble spillway on the waterside (WS) toe. Concrete headwall on the landside (LS) toe. [Additional Reference(s): DWR Levee Log, 2005. USACE San Joaquin O&M Manual 607, June 1962, (HLM 0.73)].					
FS Date: 9/17/2013

WS view: concrete headwall and CM pipe buried under debris and mud.

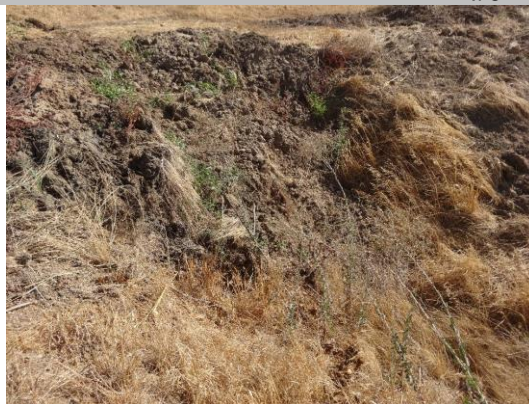
Photo 2 of 3 : UCIP\_SP\_2019\_20992\_35369.jpg

WS view: debris and mud deposited from the channel cleaning. It needs to be cleared from spillway and outlet structure.

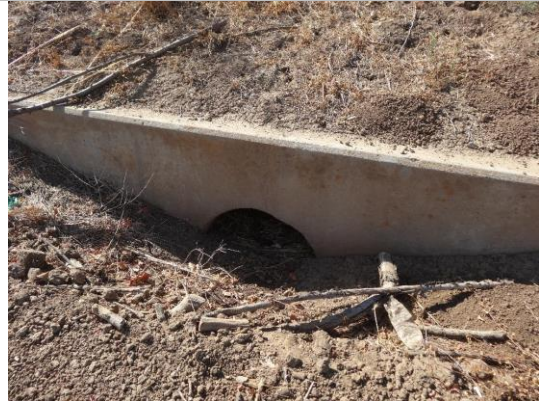
Photo 3 of 3 : UCIP\_SP\_2019\_20992\_35366.jpg

LS view: concrete headwall and CM pipe. Half of intet pipe burried.

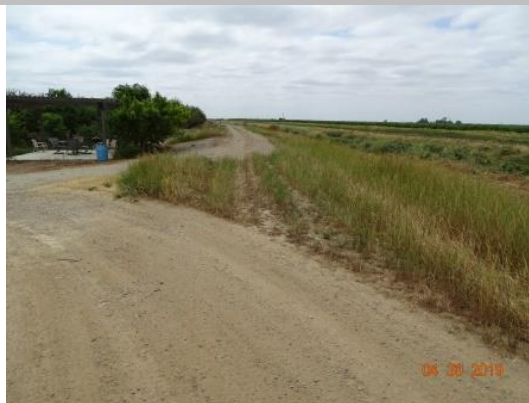
Photo 1 of 1 : SP\_2019\_NA0013\_332\_27\_20190501\_00045.jpg

View of vegetation on levee crown looking downstream. (Spring 2019)

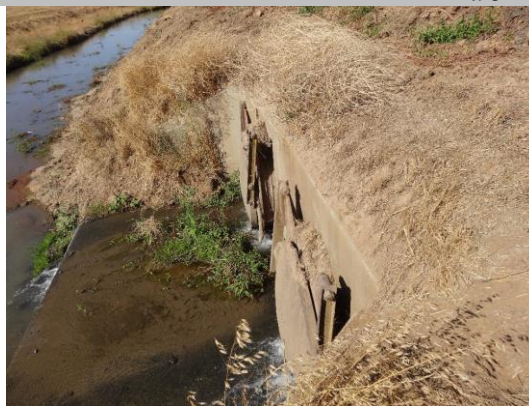
Photo 1 of 3 : UCIP\_SP\_2019\_20965\_35292.jpg

WS view: two 60" CMPs, flap gates, and headwall on channel bank.

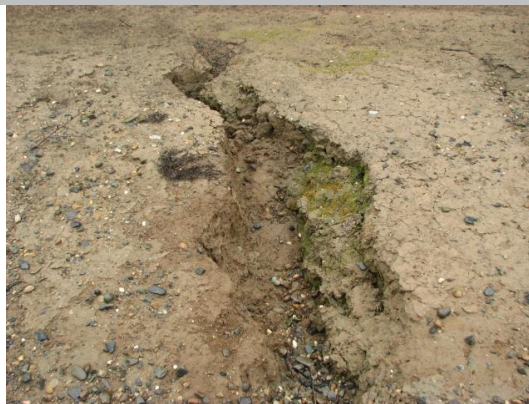
Photo 1 of 3 : SP\_2019\_NA0013\_332\_15\_20190307\_00005.jpg

Looking east at finger erosion on landward slope. (Spring 2018)

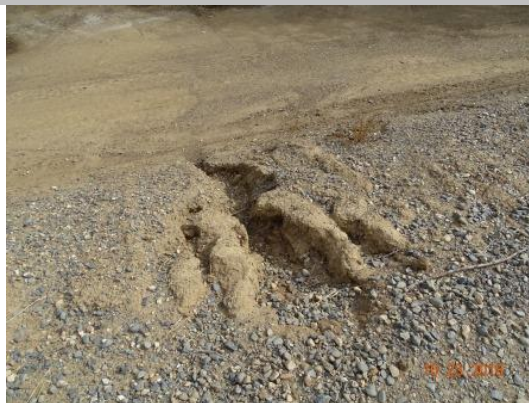
Photo 1 of 2 : SP\_2019\_NA0013\_332\_16\_20190307\_00008.jpg

View of large finger erosion in landside slope. (Fall 2018)

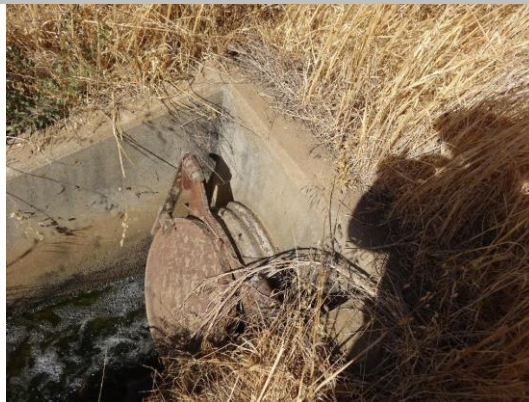
Photo 2 of 3 : UCIP\_SP\_2019\_20984\_35304.jpg

WS view: U typed concrete headwall, CM pipe, and flap gate. It was working during field inspection.

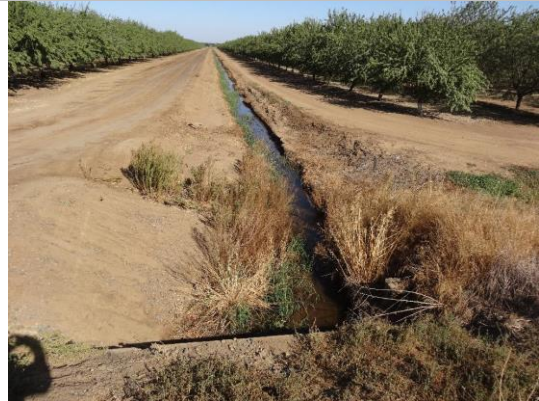
Photo 3 of 3 : UCIP\_SP\_2019\_20984\_35303.jpg

LS view: concrete headwall on levee toe and drainage ditch.

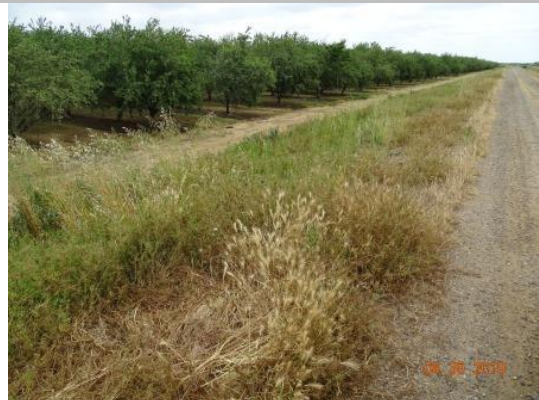
Photo 1 of 1 : SP\_2019\_NA0013\_332\_28\_20190501\_00046.jpg

View of vegetation along landside slope looking downstream. (Spring 2019)

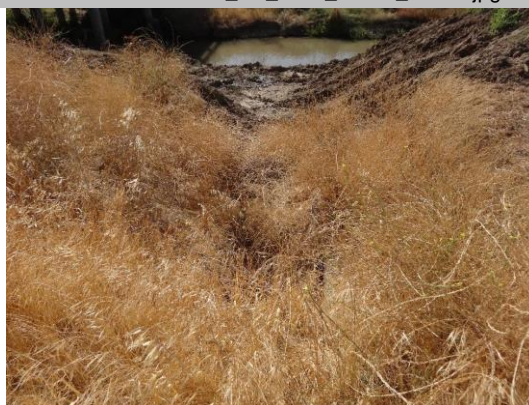
Photo 1 of 3 : UCIP\_SP\_2019\_42993\_35310.jpg

WS view: overview of outlet area and channel. Debris and vegetations on spillway.

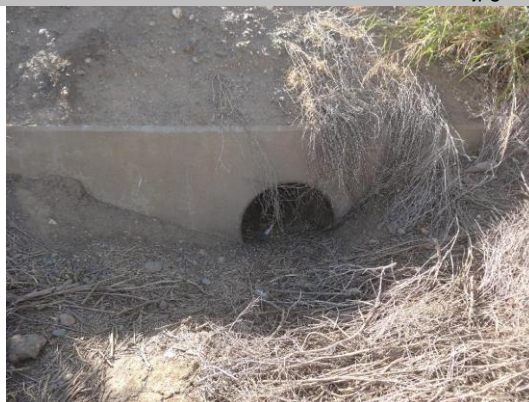
Photo 3 of 3 : UCIP\_SP\_2019\_42993\_35312.jpg

LS view: concrete headwall and CM pipe. Inlet needs cleaning. Part of inlet pipe buried.

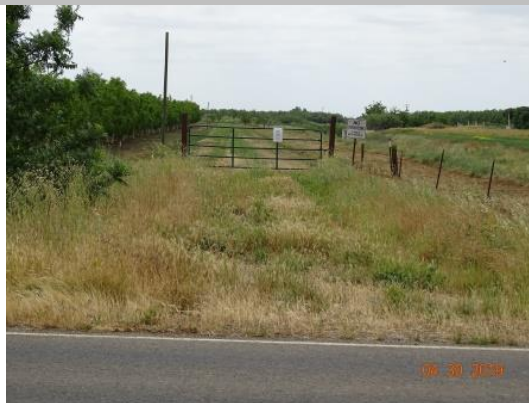
Photo 1 of 1 : SP\_2019\_NA0013\_332\_30\_20190501\_00048.jpg

View along levee crown looking downstream. (Spring 2019)

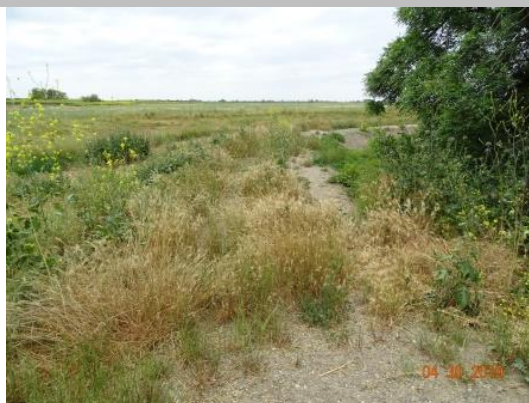
Photo 3 of 3 : SP\_2019\_NA0013\_333\_17\_20190503\_00034.jpg

View of levee crown looking downstream at access point on Mission Ave. (Spring 2019)

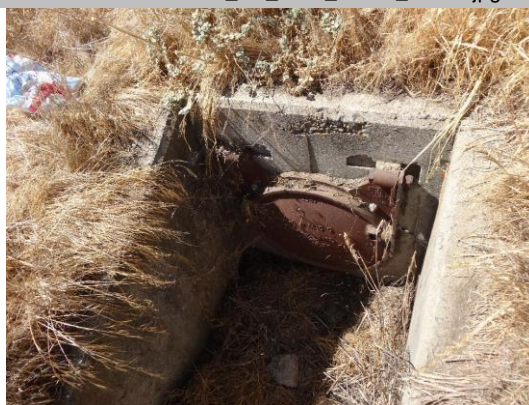
Photo 1 of 3 : UCIP\_SP\_2019\_41815\_35533.jpg

WS view: U typed concrete headwall, CM pipe, and flap gate.

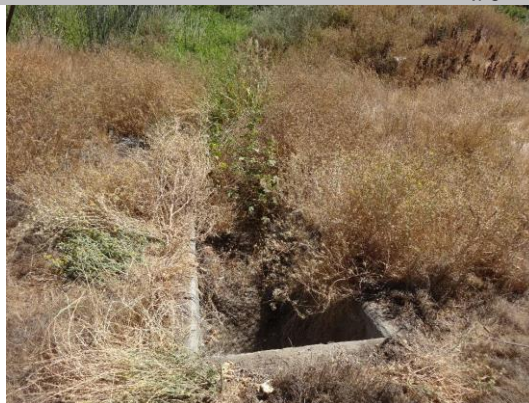
Photo 1 of 3 : UCIP\_SP\_2019\_50149\_35535.jpg

WS view: cobble spillway and channel on waterside. Dense vegetation on levee slope.

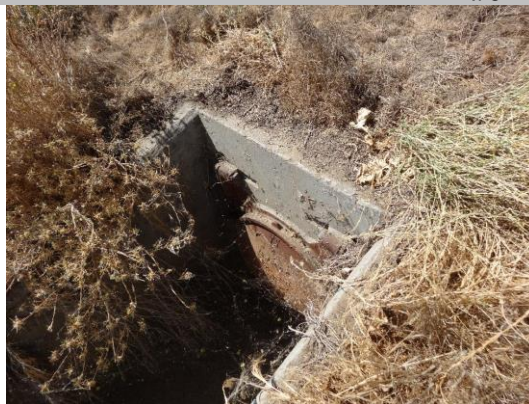
Photo 2 of 3 : UCIP\_SP\_2019\_50149\_35534.jpg

WS view: U typed concrete headwall, CM pipe, and flap gate. Vegetation needs to be cleared.

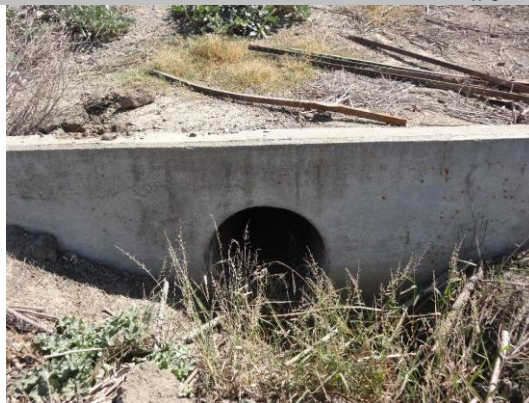
Photo 3 of 3 : UCIP\_SP\_2019\_50149\_35537.jpg

LS view: concrete headwall and CM pipe. Inlet needs clearing.

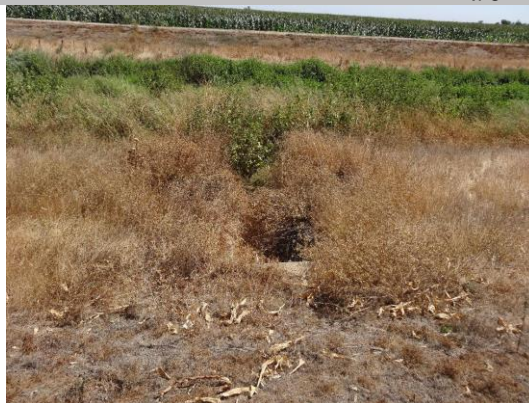
Photo 1 of 3 : UCIP\_SP\_2019\_50151\_35539.jpg

WS view: overview of spillway/outlet area on waterside.

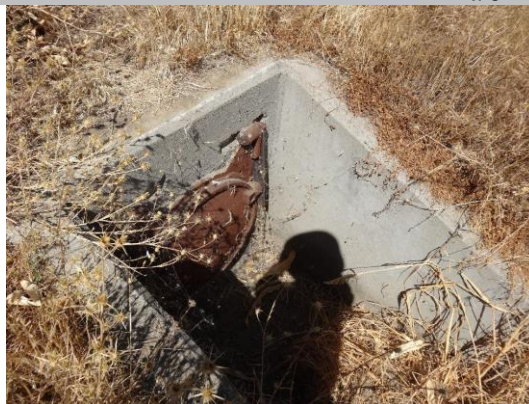
Photo 2 of 3 : UCIP\_SP\_2019\_50151\_35538.jpg

WS view: U typed concrete headwall, CM pipe, and flap gate. Vegetation needs to be cleared.

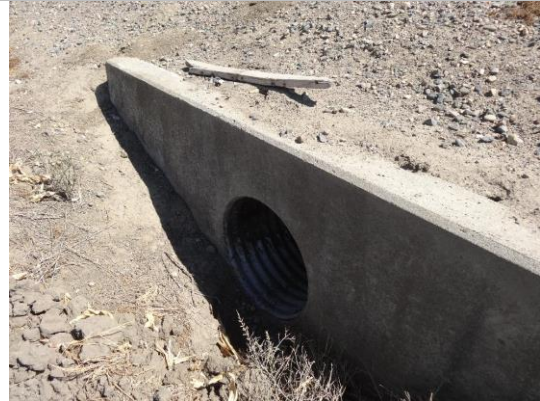
Photo 3 of 3 : UCIP\_SP\_2019\_50151\_35541.jpg

LS view: concrete headwall and CM pipe.

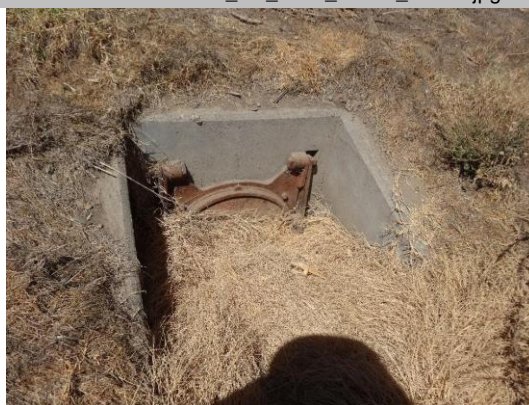
Photo 2 of 3 : UCIP\_SP\_2019\_50152\_35543.jpg

WS view: U typed concrete headwall, CM pipe, and flap gate. Vegetation needs to be cleared.

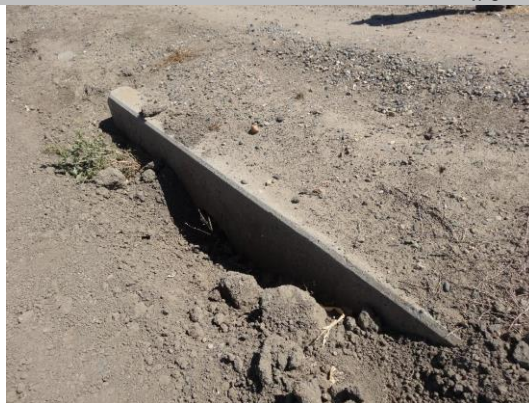
Photo 3 of 3 : UCIP\_SP\_2019\_50152\_35542.jpg

LS view: concrete headwall and CM pipe. Inlet needs clearing & cleaning.

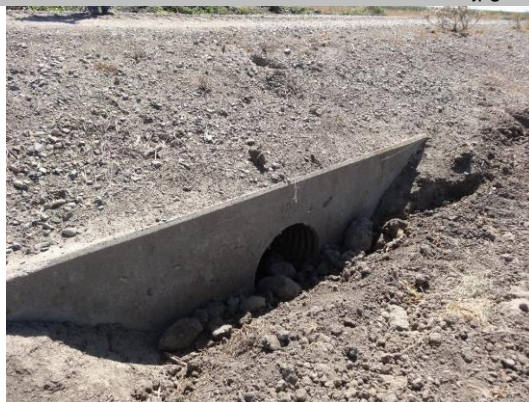
Photo 2 of 3 : UCIP\_SP\_2019\_21063\_35501.jpg

LS view: concrete headwall and CM pipe. Inlet needs clearing.

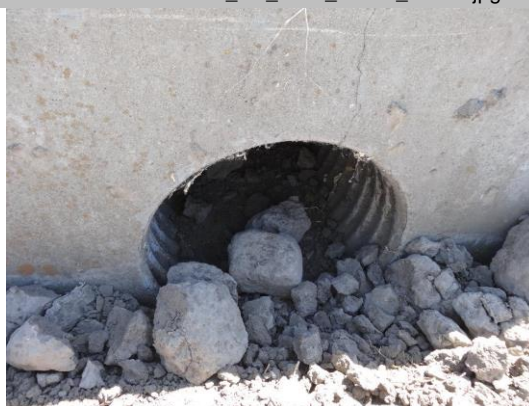
Photo 3 of 3 : UCIP\_SP\_2019\_21063\_35500.jpg

LS view: closer view of CM pipe. Inlet needs cleaning &amp; clearing.

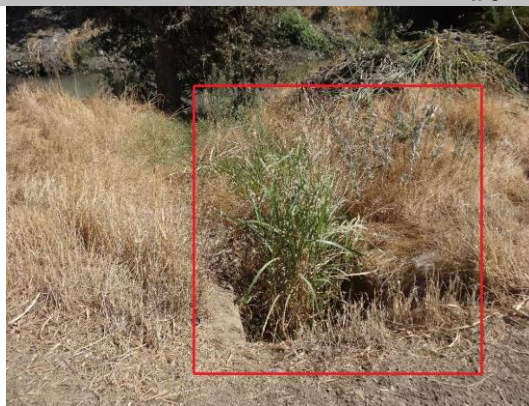
Photo 1 of 3 : UCIP\_SP\_2019\_21064\_35506.jpg

WS view: cobble spillway and channel on waterside. Dense vegetation on levee slope and spillway.

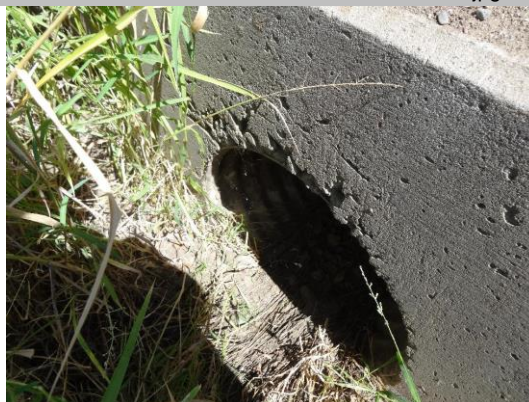
Photo 3 of 3 : UCIP\_SP\_2019\_21064\_35504.jpg

LS view: concrete headwall and CM pipe. Inlet needs clearing.

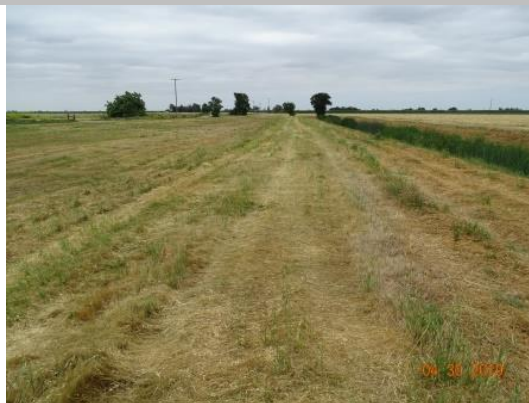
Photo 1 of 1 : SP\_2019\_NA0013\_334\_22\_20190503\_00034.jpg

View of levee crown looking downstream. (Spring 2019)

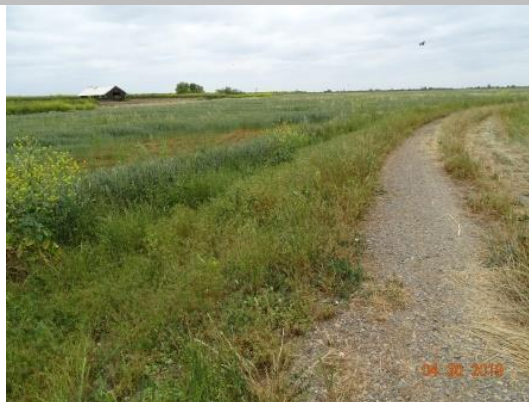
Photo 1 of 2 : SP\_2019\_NA0013\_334\_23\_20190503\_00035.jpg

View of landside slope looking downstream. (Spring 2019)

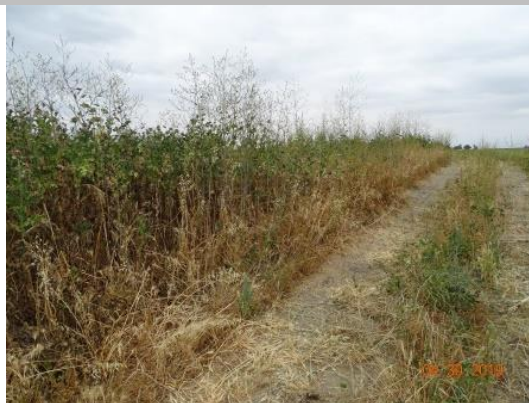
Photo 2 of 2 : SP\_2019\_NA0013\_334\_24\_20190503\_00038.jpg

View of waterside slope looking upstream. (Spring 2019)

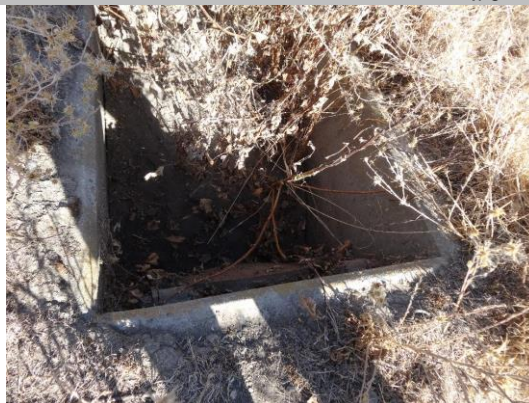
Photo 1 of 3 : UCIP\_SP\_2019\_50146\_35748.jpg

WS view: U typed concrete headwall, CM pipe, and flap gate. Vegetation needs to be cleared.

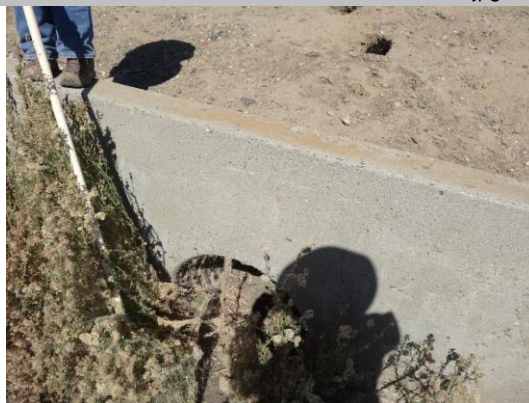
Photo 2 of 3 : UCIP\_SP\_2019\_50146\_35747.jpg

LS view: concrete headwall and CM pipe. Inlet needs clearing.

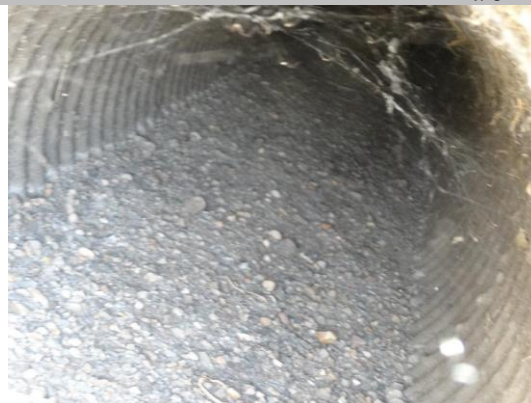
Photo 3 of 3 : UCIP\_SP\_2019\_50146\_35746.jpg

LS view: inside view of CM pipe. Inlet pipe needs clearing.

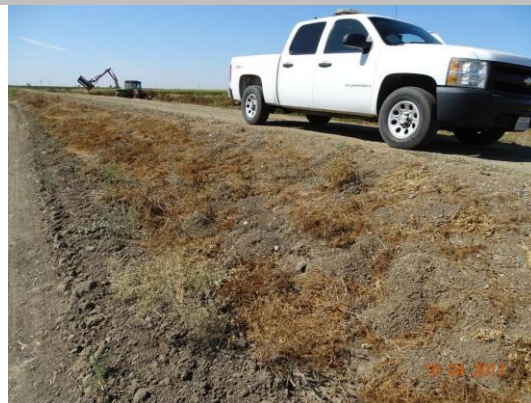
Photo 1 of 1 : SP\_2019\_NA0013\_334\_10\_20190307\_00001.jpg

Numerous rodent holes on LS slope.

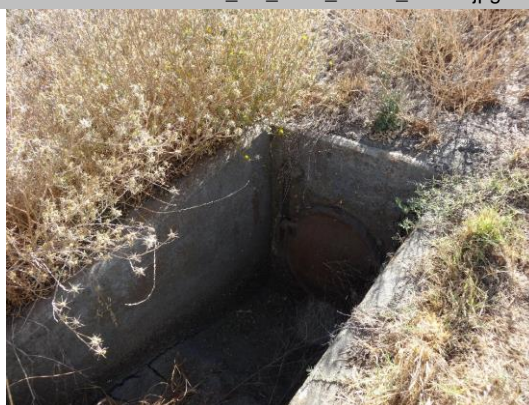
Photo 2 of 3 : UCIP\_SP\_2019\_50154\_35607.jpg

WS view: U typed concrete headwall, CM pipe, and flap gate. Vegetation needs to be cleared on spillway.

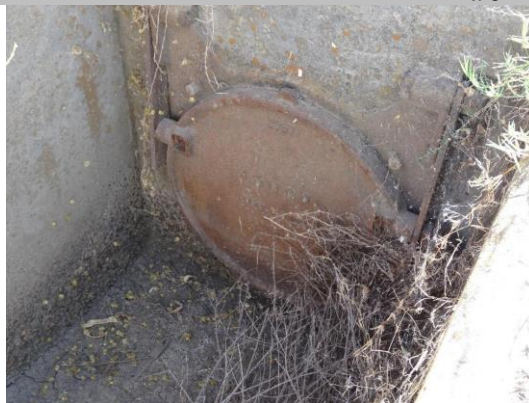
Photo 3 of 3 : UCIP\_SP\_2019\_50154\_35606.jpg

WS view: CM pipe and flap gate. Vegetation needs to be cleared.

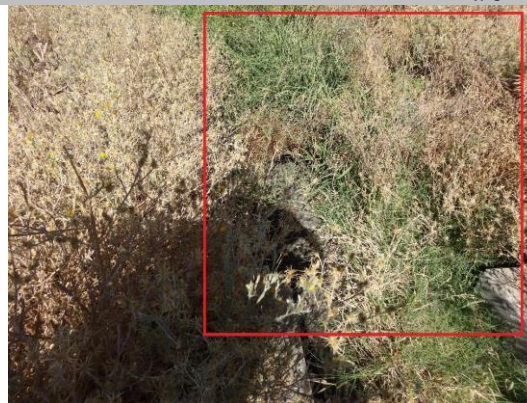
Photo 1 of 3 : UCIP\_SP\_2019\_50148\_35613.jpg

WS view: Dense vegetation on levee slope and spillway.

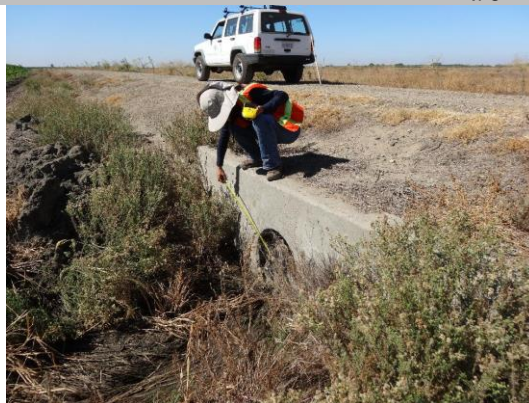
Photo 3 of 3 : UCIP\_SP\_2019\_50148\_35611.jpg

LS view: concrete headwall and CM pipe.

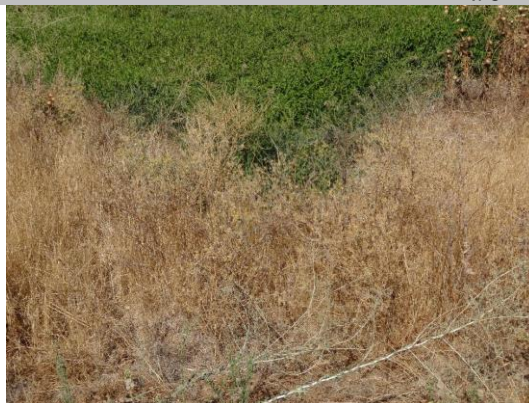
Photo 1 of 3 : UCIP\_SP\_2019\_50155\_35642.jpg

WS view: Dense vegetation on levee slope and spillway.

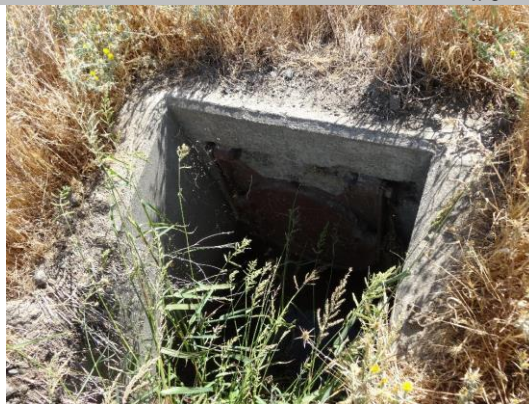
Photo 2 of 3 : UCIP\_SP\_2019\_50155\_35641.jpg

WS view: U typed concrete headwall, CM pipe, and flap gate. Vegetation needs to be cleared.

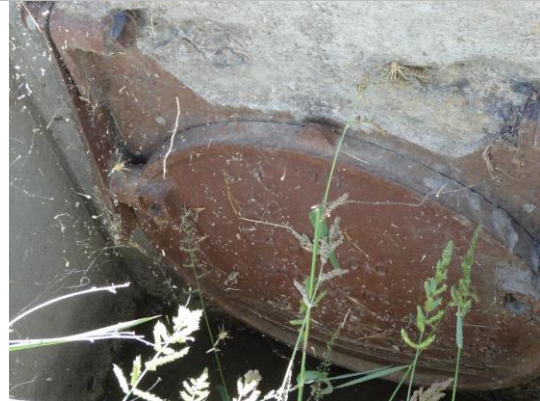
Photo 3 of 3 : UCIP\_SP\_2019\_50155\_35640.jpg

WS view: CM pipe and flap gate. Vegetation needs to be cleared.

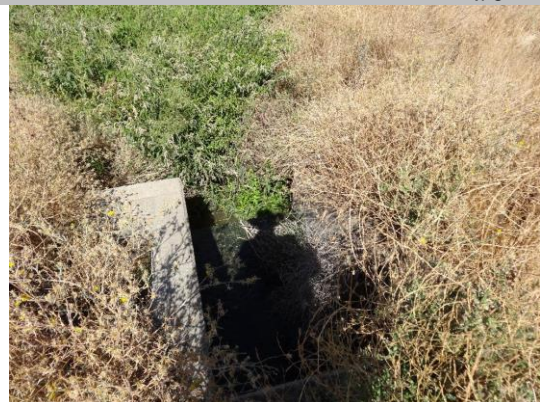
Photo 1 of 3 : UCIP\_SP\_2019\_21126\_35652.jpg

WS view: concrete spillway and channel on waterside. Dense vegetation on levee slope and spillway.

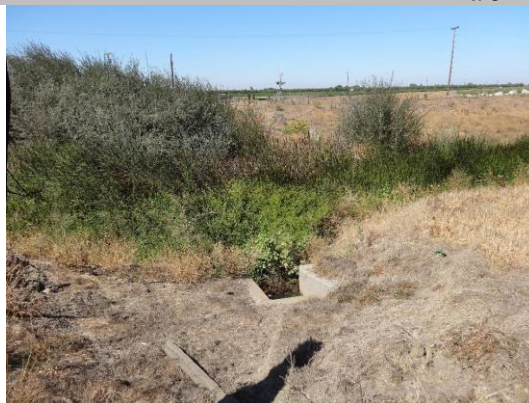
Photo 1 of 3 : UCIP\_SP\_2019\_21127\_35657.jpg

WS view: U typed concrete headwall and channel on waterside.

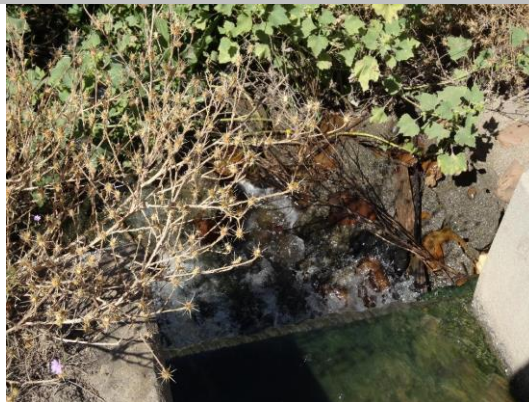
Photo 2 of 3 : UCIP\_SP\_2019\_21127\_35656.jpg

WS view: concrete headwall and concrete spillway on waterside.

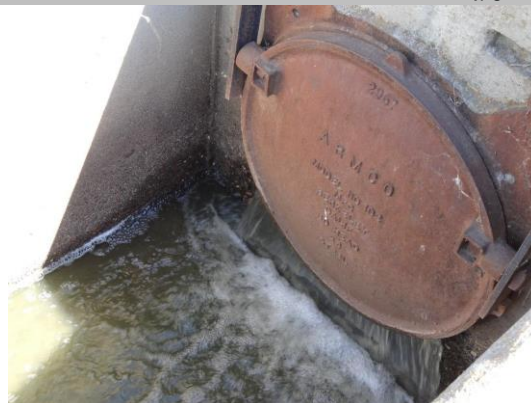
Photo 3 of 3 : UCIP\_SP\_2019\_21127\_35655.jpg

WS view: U typed concrete headwall, CM pipe, and flap gate. Drainage was working during survey.

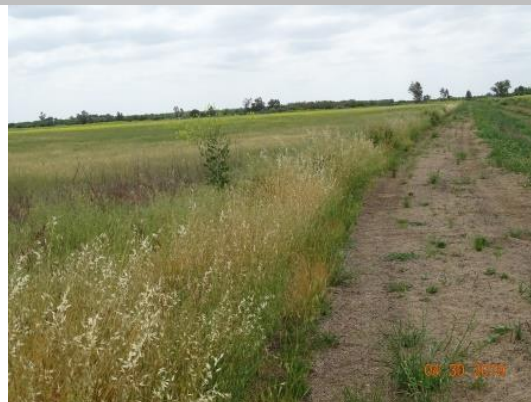
Photo 1 of 1 : SP\_2019\_NA0013\_334\_12\_20190503\_00041.jpg

View of landside slope looking downstream. (Spring 2019)

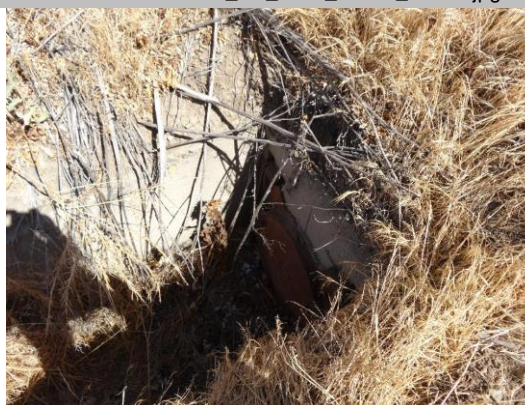
Photo 1 of 3 : UCIP\_SP\_2019\_52888\_35709.jpg

WS view: concrete spillway and channel on waterside. Dense vegetation on levee slope and spillway.

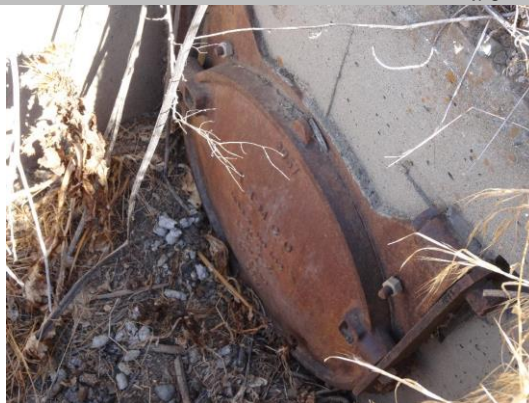
Photo 2 of 3 : UCIP\_SP\_2019\_52888\_35708.jpg

WS view: U typed concrete headwall, CM pipe, and flap gate. Spillway needs to be cleared.

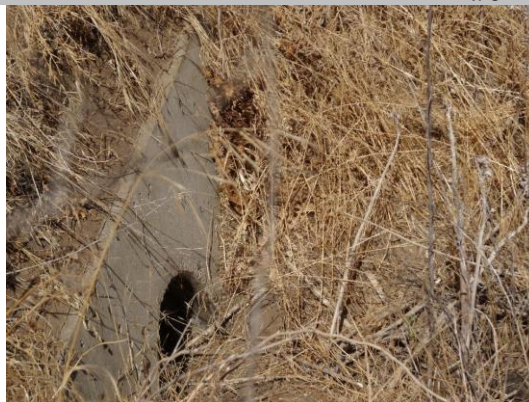
Photo 3 of 3 : UCIP\_SP\_2019\_52888\_35707.jpg

LS view: concrete headwall and CM pipe. Inlet silt needs clearing.

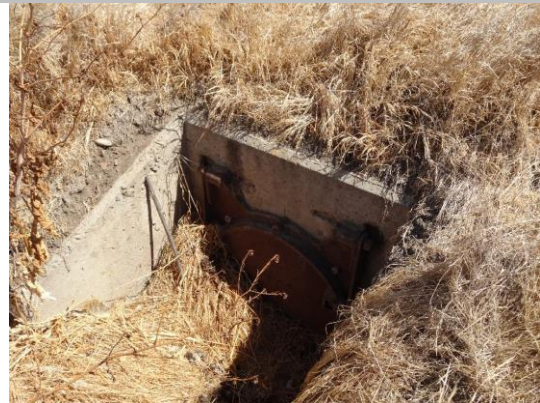
Photo 1 of 3 : UCIP\_SP\_2019\_50153\_35745.jpg

WS view: U typed concrete headwall, CM pipe, and flap gate. Dirt and vegetations need to be removed and cleared.

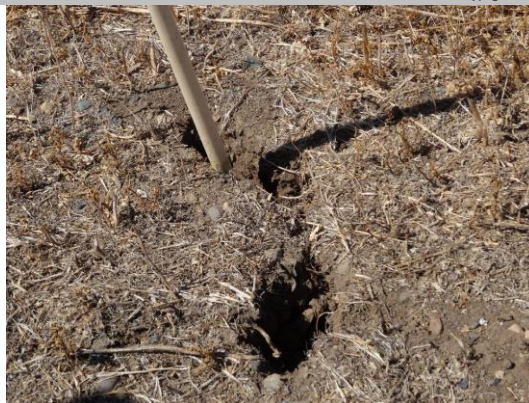
Photo 2 of 3 : UCIP\_SP\_2019\_50153\_35744.jpg

WS view: significant levee cracks along the pipealignment. Needs detailed investigation on the issue.

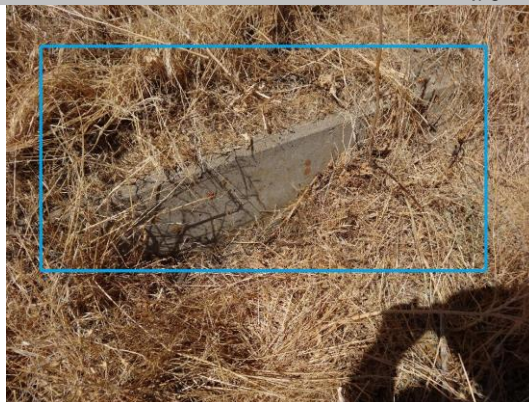
Photo 3 of 3 : UCIP\_SP\_2019\_50153\_35743.jpg

LS view: concrete headwall and buried CM pipe. Dirt removal and clearing needed in inlet.
